SERVICE ALERT

Issued 12th June 2015

Andair Ltd.,
Unit 1 Dunsbury Business Park,
Fullood Road,
HAVANT,
Hampshire PO9 5AX
UK.

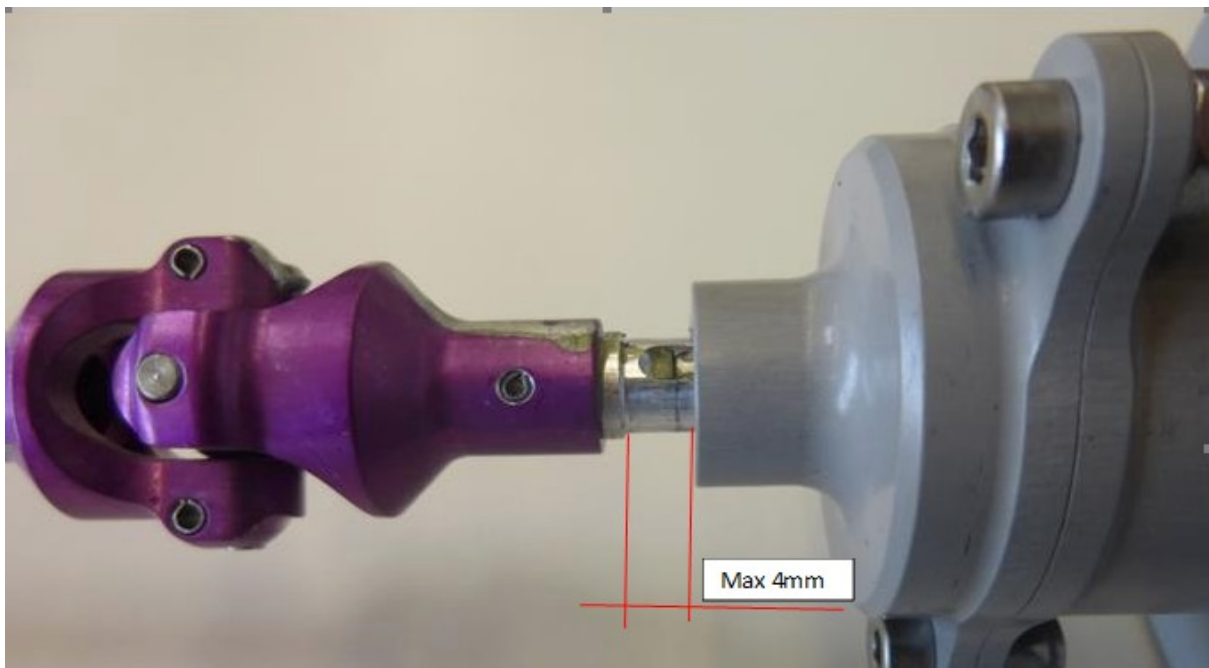
This Service alert applies to all Diamond Aircraft fitted with this extension system. It has been brought to our attention that there could be a possible lack of engagement between the universal joint assembly and the top of the valve assembly. It is requested that a check be carried out to establish a minimum of engagement of 5mm with the dowel in the valve assembly. The picture below gives a maximum dimension of 4mm. Less than this can be considered satisfactory, this gives over 5mm engagement. Greater than this, the assembly should be investigated further and a new longer dowel be fitted. The longer dowels can be supplied.
